Region 5 South Central Alabama Rural Transportation Planning Program

Bullock, Butler, Crenshaw, Lowndes, Macon and Pike Counties

Rural Transportation Needs and Issues And Long-Range Planning, 2023 – 2024

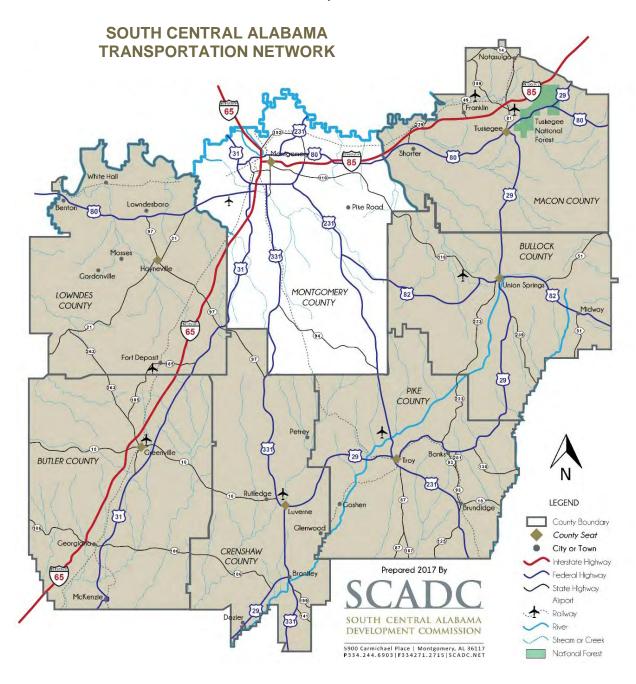
smaller municipalities are not included on this regional system. Even though it is not a part of the South Central Alabama Region, the City of Montgomery is the metropolitan hub for all six counties in the region. With its health, employment and shopping resources, Montgomery is probably the most significant destination for the total population, and even more so for those persons who are in need of specialized services. Major highways are shown on the map on the following page.

Interstates Federal Highways		State Hi	State Highways	
Interstate 65	US Highway 80	Alabama Highway 10	Alabama Highway 110	
Interstate 85	US Highway 82	Alabama Highway 14	Alabama Highway 125	
	US Highway 231	Alabama Highway 21	Alabama Highway 130	
	US Highway 331	Alabama Highway 49	Alabama Highway 141	
		Alabama Highway 51	Alabama Highway 167	
		Alabama Highway 55	Alabama Highway 185	
		Alabama Highway 87	Alabama Highway 189	
		Alabama Highway 93	Alabama Highway 223	
		Alabama Highway 97	Alabama Highway 239	
		Alabama Highway 106	Alabama Highway 263

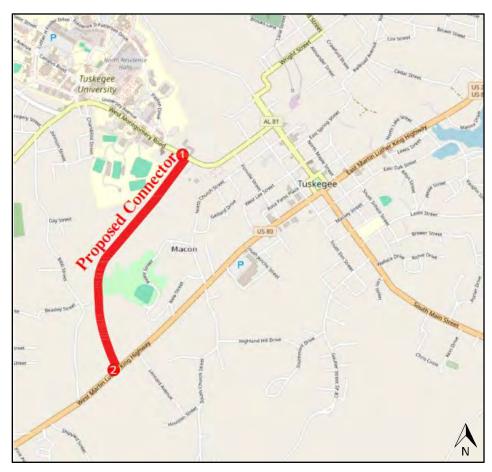
Study Area Map: Proposed Connector Road, Tuskegee, AL

U.S. Highway 80 is a four-lane, undivided roadway with a posted speed limit of 45 miles per hour in the vicinity of where the proposed campus connector is planned. U.S. Highway 80 is functionally classified as a Minor Arterial. Montgomery Road, in the vicinity of the proposed connector roadway is a two-lane roadway with a two-way left turn lane. The roadway has a posted speed limit of 25 miles per hour. Montgomery Road is functionally classified as a Collector. The proposed Connector Road is planned as a two-lane roadway with a 35 miles per hour design speed. A separate bike lane and sidewalk will also be constructed in the east side of the roadway.

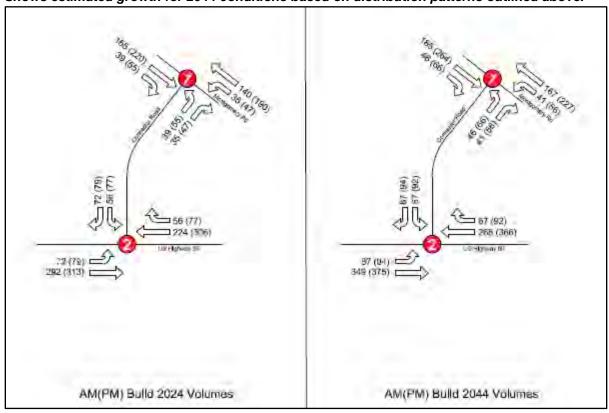
Estimated Future Traffic Volume
Shows estimated growth for 2044 conditions based on distribution patterns outlined above.

Traffic distribution for traffic expected to travel the proposed connector road in the future is based upon existing population concentrations, traffic patterns, and access to the roadway network in the vicinity. The patterns anticipated for traffic that would access the campus are summarized and illustrated below:

- Approximately 10% of the existing and future eastbound traffic on U.S. Highway 80 will divert
- onto the Connector Road and travel north to the campus;
- Approximately 10% of the existing and future westbound traffic on U.S. Highway 80 will divert
- onto the Connector Road and travel north to the campus;
- Approximately 10% of the existing and future eastbound traffic on Montgomery Road will divert onto the Connector Road and travel south to U.S. Highway 80; and
- Approximately 10% of the existing and future westbound traffic on Montgomery Road will divert onto the Connector Road and travel south to U.S. Highway 80.

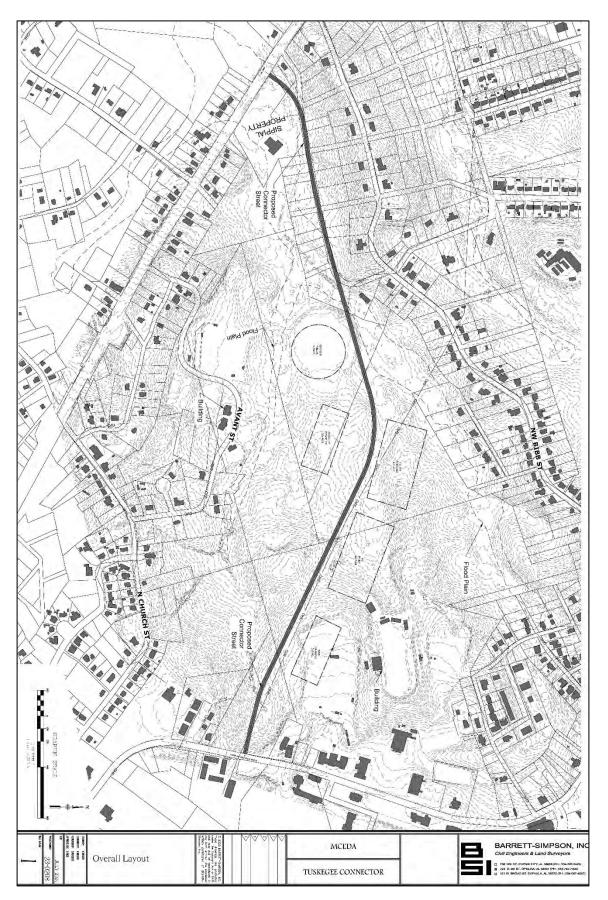
The preliminary design and location of the proposed connector road is shown on the following page and is available from SCADC.

- Construct the northbound approach on the Connector Road with a left turn and right turn lanes
- at Montgomery Road)
- Install side-street stop control for the northbound approach of the Connector Road.
